Manhole Inspection Summary

Manhole # S08YY1001MH

Insp Date: **10/11/06 9:43 AM**

Location Address: **4150 CREST HEIGHTS AVE** Cross Street: **FALLSTAFF RD**

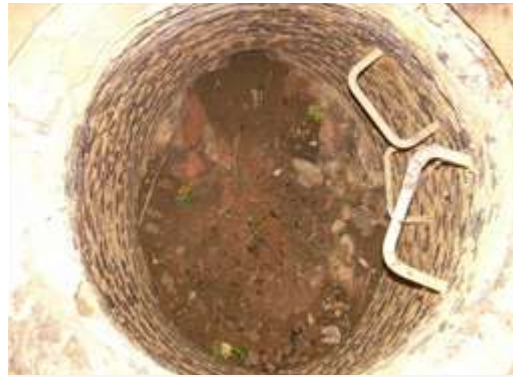
Top View

Channel Material: **Brick** ☐ Parged ☒ **Debris** (not Condition related)
Channel Exposure: **Fully Open** Junc Dist: **0** nearest .5 ft. Azimuth:
Condition: ☒ Sound ☐ Cracked ☐ Root Intrusion ☐ Deteriorated ☐ Leaks ☐ Debris

Channel debris.

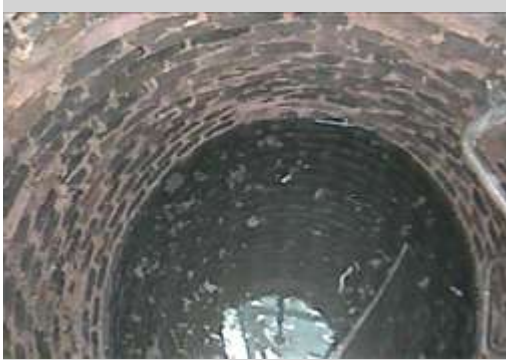
1ST visit Top View

Comments **6/29/06 - Active surcharge. Revisited on 10/11/06 - The inspection was completed.**

Surcharge ☒ **Evidence Of Surcharge** Depth: **1.5** (ft.) ☒ **Active Surcharge Present**

Active surcharge.

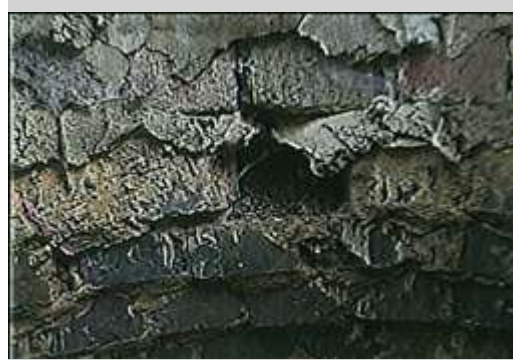
Defect

Chimney / Frame Adjustment ☒ Exists Material: **Brick** ☐ Parged Height: **3** (in.)
Condition: ☐ Sound ☐ Cracked ☐ Root Intrusion ☒ **Loose Brick** ☒ **Deteriorated**
Infiltration: ☐ None ☒ **Joint** ☐ Cracks ☒ **Mortar** ☐ Roots ☐ Wall

Corbel Material: **Brick** ☐ Parged Type: **Concentric/Eccentric**
Condition: ☐ Sound ☐ Cracked ☐ Root Intrusion ☐ Loose Brick ☒ **Deteriorated**
Infiltration: ☐ None ☐ Joint ☐ Cracks ☒ **Mortar** ☐ Roots ☒ **Wall**

Adjustment and Corbel deterioration and infiltration.

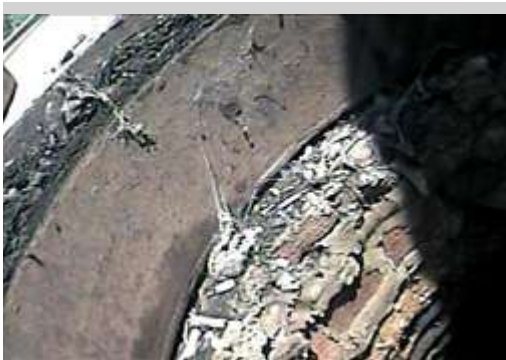
Defect

Frame Offset: **3** (in.) Condition: ☐ Sound ☐ Cracked ☒ **Leaks**

Frame leaks. Adjustment deterioration, loose brick and infiltration.

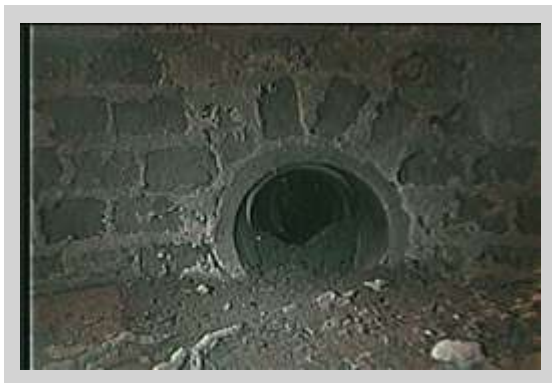
Pipe Out @ 12 O'Clock

Barrel Material: **Brick** ☐ Parged
Shape: **Circular** Diameter: **38** (in.) Length: (in.)
Condition: ☐ Sound ☐ Cracked ☐ Root Intrusion ☐ Loose Brick ☒ **Deteriorated**
Infiltration: ☐ None ☐ Joint ☐ Cracks ☒ **Mortar** ☐ Roots ☒ **Wall**

Barrel deterioration and infiltration.
